Expert opinion on the technical condition of purlins and girders in the roof of a slag storage hall

The subject of the article is the trough reloading hall located on the premises of ArcelorMittal Poland S.A. in Dąbrowa Górnicza. The main aim of the analysis was to assess the technical condition of the roof slats and girders of the hall, and to strengthen the existing structure.

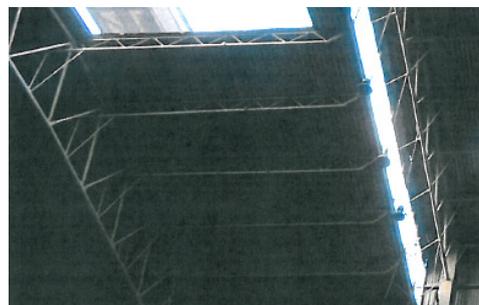
Fig. 5. View of the roof structure - purlins

- clear and permanent buckling of parts of the truss purlins,
- too little support of the truss lower flange on the gusset plate of the column,
- damage to the housing structure of the raised hall.

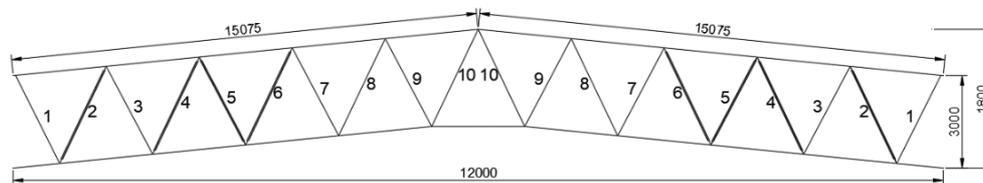
Fig. 7. List of roof girder bars with exceeded load

In the W15, W16, W17 and W18 roof girders, the exceedance occurred in diagonals no. 2, 4, 5 and 6 (Fig. 7).

- The load capacity conditions for the upper and lower flanges have not been exhausted.
- The load-bearing capacity conditions for diagonal no. 2, no. 4, no. 5 and no. 6 were exceeded.
- Due to the fact that the reinforcement of the roof structure is to be made without dismantling the structure, overlays stiffening the diagonals were used.
- The overlays are designed according to the changing diameters of the diagonal, they are to be made of steel pipes with internal diameters equal to the external diameters of the diagonal and the wall thickness of 6 mm. The overlays increase the load capacity of the diagonal by increasing their flexural stiffness. The covers are fixed with M10 screws, class 8.8.

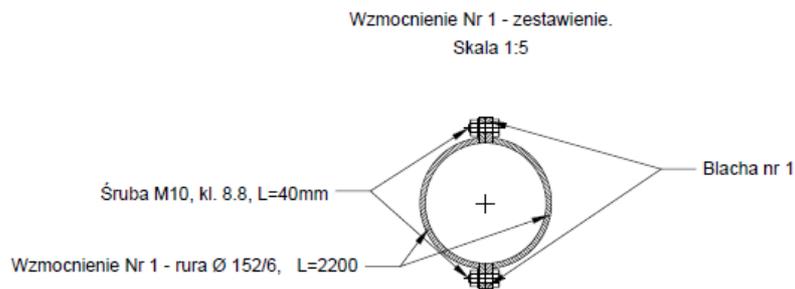
Fig. 9. Strengthening the cross-brace of the roof girders

For the diagonal no. 1 and the W16 girder, stiffening solutions are presented in Figure 9.

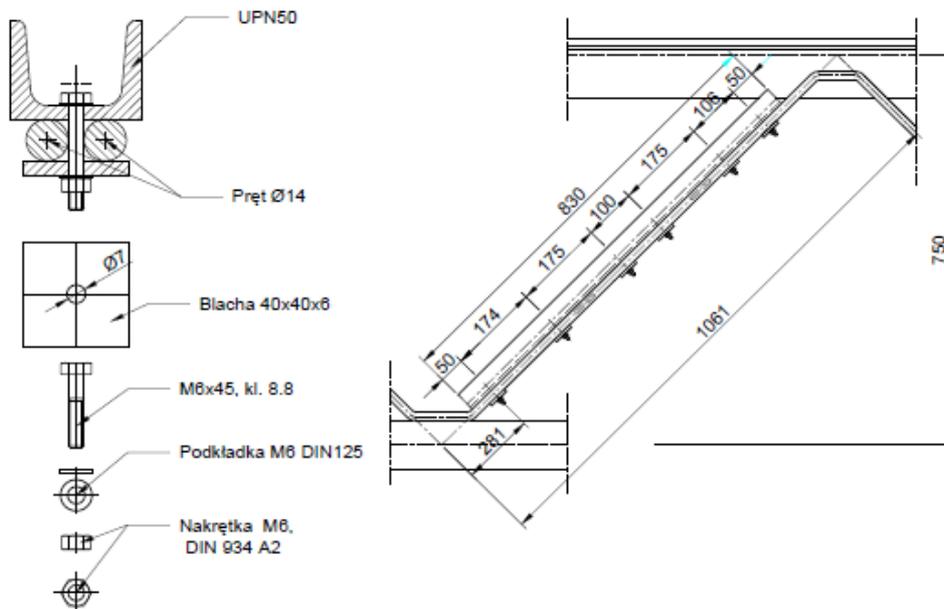
Fig. 10. Strengthening the cross-brace of the lattice purlins

- The load capacity conditions for the upper and lower flanges have not been exhausted.
- The load-bearing capacity conditions for the supporting diagonal were exceeded.

- Due to the fact that the reinforcement of the roof structure is to be made without dismantling the structure, an overlay stiffening the diagonals was used.
- The overlay was designed from an UPN channel section, the solution of the diagonal stiffening is shown in Figure 10 (solution for P3 purlins).
