## Analysis of the harmful influence of parasitic vibrations using the example of a failure in the building structure of a school gymnasium

Wiesław Liszewski<sup>1</sup>

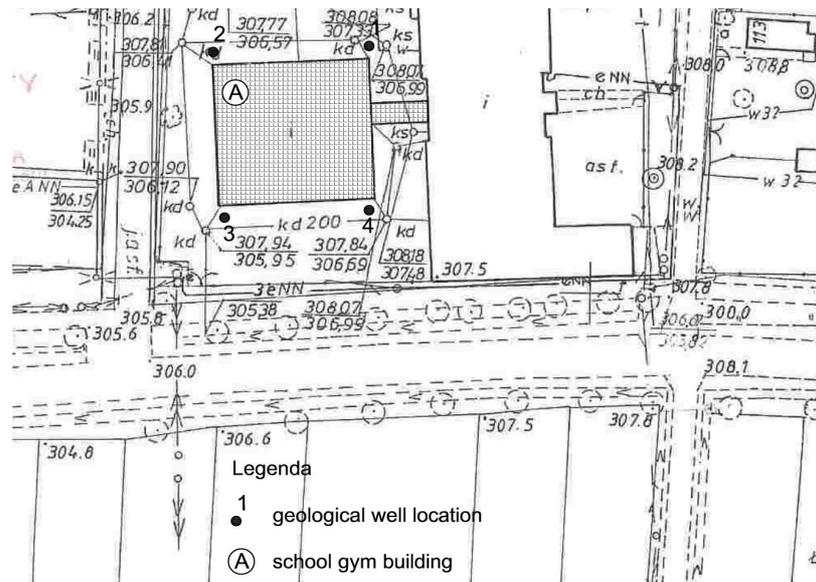
Fig. 1. Location of geotechnical drilling

After the tests, it was found that under some of the building's foundations (western and southern parts) there were loose embankments ( $l_D = 0.30 \div 0.50$ ) with a thickness of up to 1.1 m. The embankments consist of sand, soil, construction debris and organic sediment. Under the remaining part, there are fine and medium-compacted sands as well as sandy and dusty loams in a hard-plastic and semi-compact state. The bearing layers are sloped to the south-west. Gravel and compacted gravel lie deeper. The discovered foundation conditions were defined as varied and generally unfavorable. Due to the lack of any data on the method of preparing the embankments, the most reliable variant was the construction of the embankments in an uncontrolled manner.

The conclusions from the study indicated that after the ground was loaded with the building, its secondary consolidation and uncontrolled settlement took place. The amount of subsidence was determined to be varied due to the variable thickness of the embankments and the varying degree of compaction. In addition, the possibility of infiltrating water runoff (south-west on the clay ceiling), which resulted in the removal of the smallest particles from outside the building outline, was indicated. This also caused additional loosening of the soil. It was shown that such foundation conditions had a direct impact on the settlement: the maximum in the south-west corner, and the minimum in the line of the eastern wall. According to opinion, this resulted in the deflection of the building (convex curve) and, consequently, the creation of significant shear and tensile forces in the walls of the building. Consequently, as a recommendation, in order to stabilize the ground, micropiling of the building foundation was performed.

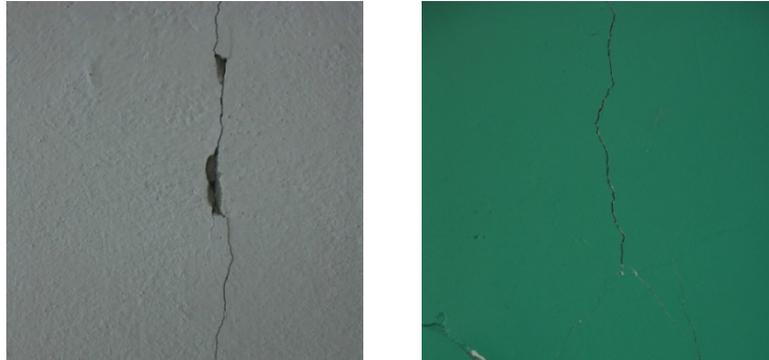
Fig. 2. Examples of scratches revealed during the vision of the object

In the longitudinal (northern) wall of the back-up facility, numerous scratches were found along the contact point of the wall with the ceiling, and vertical scratches in the sill walls. Similar cracks are also present in the longitudinal walls of the connector – especially in the northern wall. Vertical features of the back end walls were also found. Scratches are visible from the inside and outside.

There were two vertical scratches on both gable walls. The largest cracks occur at the point of connections of the gable walls with the internal longitudinal wall along the internal axis, with the greatest intensity and crack opening at the level of +5.8. It proves the lack of the rim or the continuity of the structure in this place or the lack of its anchoring in the core and the joist of the longitudinal wall.

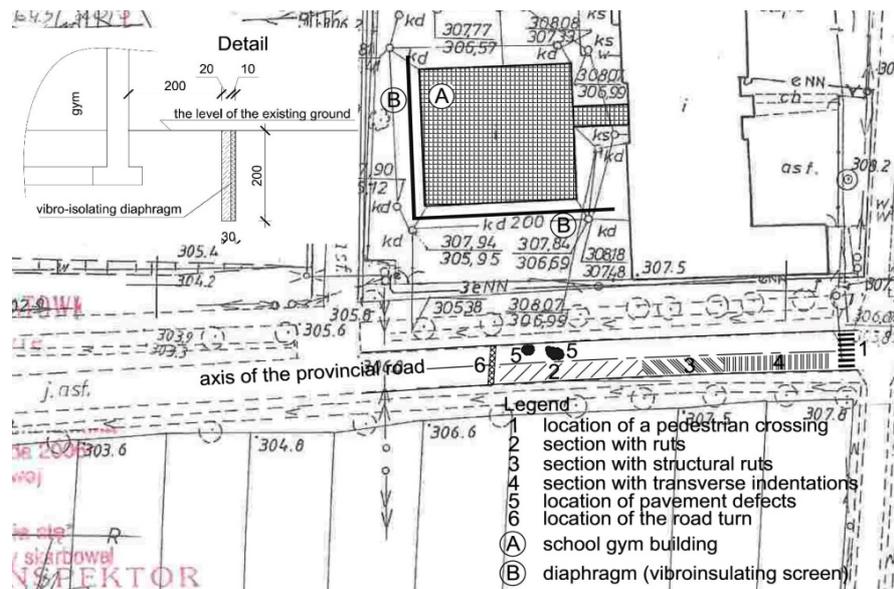
Based on an interview with the administrator of the facility, attention was drawn to the subjective feelings of users related to the behavior of the facility during vehicle traffic on the directly adjacent provincial road. The technical condition of the provincial road was inspected. It was noticed that a pedestrian crossing was located at the height of the building complex, and before the rutting into structural ruts and ending with dents from the set of vehicles was revealed, it is also very important to reveal defects in the pavement and breakthrough in the pavement on the opposite lane.

During the assessment of the object and the condition of the structure, it was noticed that during the passage of truck tractors with semi-trailers, vibrations of the object are felt at the moment of passing by vehicles on the road section with specific failures of the surface condition. The influence of the transferred mechanical waves in an elastic soil medium on the object and on the condition of the structure was recognized [1, 2]. It was unequivocally recognized that the main destructive factor for the structure is the parasitismic effect and it was ruled that in order to protect the building, the source of wave propagation should be minimized by damping it with the use of vibro-isolating elements [3].

Fig. 3. Graphic description of the surface condition of the voivodeship road and the location of the diaphragm

In order to limit the impact of vibrations resulting from the source of their propagation (the provincial road) and to inhibit the possible suffocation phenomenon, it was recommended to build a diaphragm on the southern side of the building at a distance of 2.0 m from the building to a depth of 2.0 m below the ground. It was found that the execution of a reinforced concrete wall with dimensions  $b \times h \times L = 0.20 \times 2.0 \times 55.0$  (27.0 + 28.0) m (W x H x L) and retrofitting the diaphragm with a vibro-insulating layer using 10 cm of vertical EPS Aqua type insert will effectively solve the problem in question. In addition, the method of scratches and cracks was specified as reinforcement of the wall using steel bars with a diameter of 6 to 8 mm, concreted in grooves cut perpendicular to the crack (preferably in joints, every 2nd joint). It was recommended to make the length of the furrows to reach a minimum of 50 cm beyond the fracture. After thorough cleaning of the grooves (e.g. using compressed air) and wetting them thoroughly, it was indicated that they should be filled with a thick cement mortar 1: 3 and a rebar of appropriate length should be inserted into the groove (reinforcement inserts were recommended to be galvanized) [4, 5].

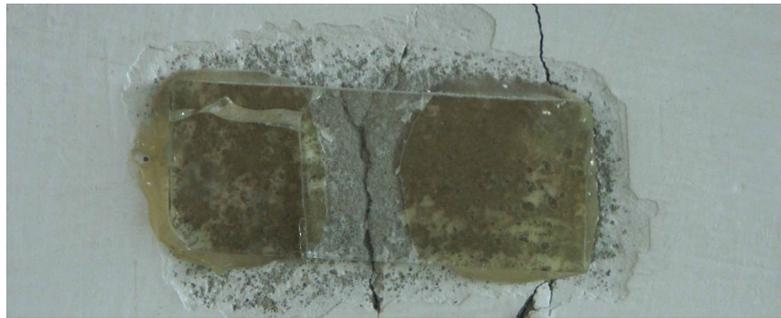
Fig. 4. View of the undamaged seal confirming the deterioration of the structure has been stopped

After the recommendations were implemented, another inspection was carried out, which confirmed the effectiveness of the designed solution.
