## Cracking on the surface of concrete multi-storey car parks – causes and repair

Beata Ordon-Beska<sup>1</sup>

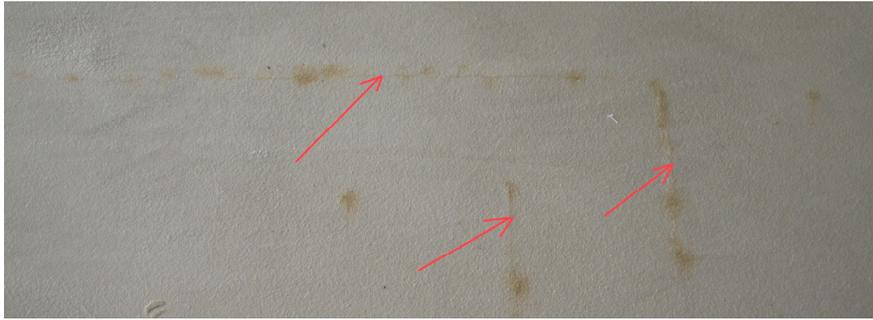
On the upper surface of the parking slab, there are numerous scratches running in accordance with the reinforcement arrangement, directly above it, as for example in Figure 1. There are also traces of corrosion in the form of rusty discoloration and bulges running along the bars, indicating the detachment of the concrete from the rods.

Fig. 1. Cracks over the top reinforcement bars

Documented in Figure 1 damage is an example of the effect of making a cover of insufficient thickness. The cause of this type of cracking is plastic settling of the concrete mix and the influence of the reinforcement on its consolidation. The diameter of the reinforcement is important here, where the thicker it is, the more strongly it affects the damage presented. It should be noted that for the presented measurements, the diameter of the reinforcement  $\varnothing 10$  was assumed based on the detailed design, while the measurements of the reinforcement diameter in the area covered by Figure 1 showed a diameter significantly exceeding 30 mm. In the opinion of the author, this is not the real diameter, but the obtained results may indicate an overlap of reinforcing meshes, which, also through the local intensity of plastic settlement of concrete and its consolidation, may contribute to the described damage.

In places where there are cracks above the reinforcement, the bulging concrete still bonded with the slab and the fully detached fragments should be removed. It is necessary to clean the reinforcement of rust and cover the concrete and the reinforcement with a tack coat, and then fill the cavities. In places where the concrete is not buckled and no rusty discoloration is visible, it is enough to inject the scratches with epoxy resins.

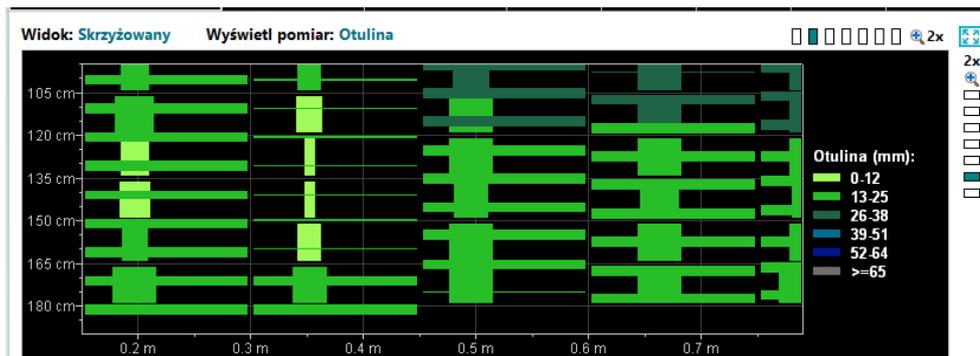
In the area shown in Figure 1, the cover thickness was measured. The Profometr PM-650 was used for this purpose. A "Crossed" measurement was used, that is, a two-way measurement on a surface of freely defined dimensions. It consists of making any number of band measurements of a given width in two mutually perpendicular directions. A standard accuracy has been adopted that allows for testing the cover from 0 to 70÷100 mm with an accuracy not exceeding ±2 mm. The measurement results presented in Figure 2 indicate a large variability of the cover. It can be local even smaller than 12 mm, and its maximum thickness may not exceed 40 mm. The dominant cover thickness is from 13 to 25 mm. It should be added that in the object to which the presented research relates, the author located a single rebar, the end of which protruded slightly above the floor surface.

Fig. 2. Cover thickness map

In both presented fragments, the cover does not meet the durability requirements, because the XF4 exposure class requires that the cover of the parking slab reinforcement is at least 40 mm [13]. The minimum cover given in PN-EN 1992-1-1 for the XD3 class (for cyclically wet

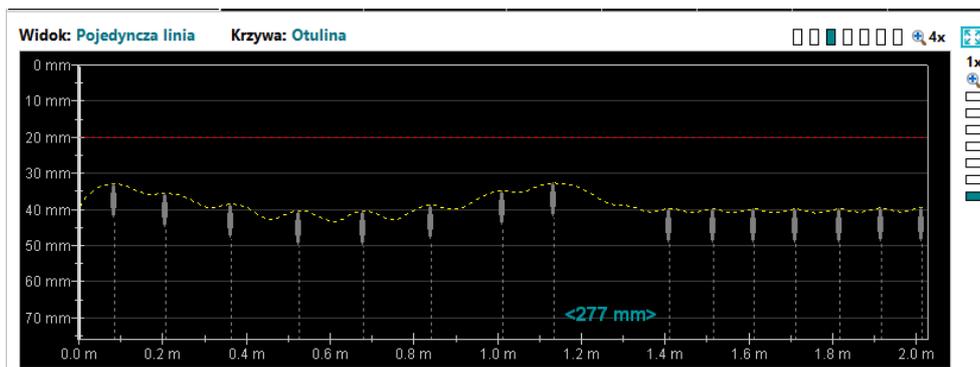
Figure 3 shows the course of the buffer zone measured on a different level of the parking lot. The test was performed starting from the line connecting two adjacent columns, in the middle of the slab field length.

The drawing shows significant variability of the cover. In the presented fragment, the gap is from 32 to 40 mm, and taking into account the measurement error, it can be at most from 33 to 41 mm. The given range was determined after adding the measurement error of  $\pm 1$  mm to the depth of 50 mm.

Fig. 3. An example image of the location of the reinforcement in the span area

The course of the cover thickness variability indicates a great carelessness in the arrangement of the reinforcement. There are two-way slopes on the parking deck to drain the water. However, changes in the thickness of the cover do not correspond to their shape.

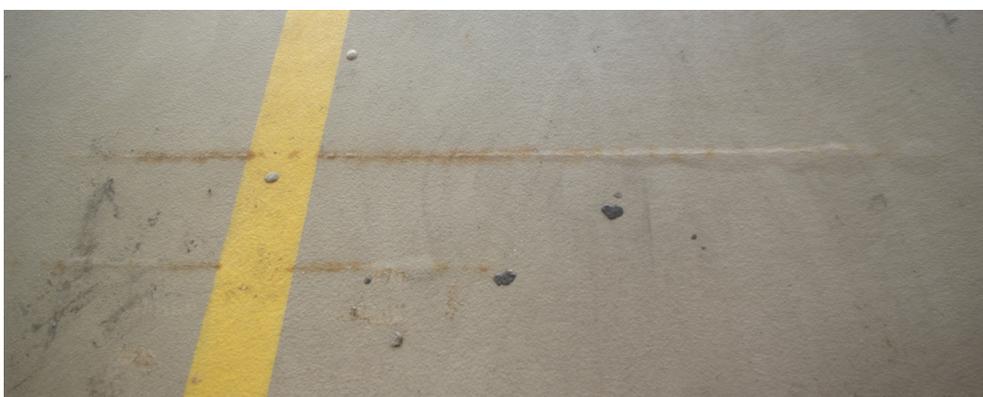
The effects of the development of the described scratches are visible in the form of rusty discoloration. The detachment of concrete above the reinforcement bars, visible in Figure 4, is the result of corrosion development and the impact of seasonal temperature changes, i.e. freezing and thawing.

Fig. 4. Detachment of concrete along the length of the reinforcement
