## Improving the energy efficiency of church buildings

Aleksandra Repelewicz<sup>1</sup>

The implementation of thermal renovation of residential and public buildings is becoming more and more popular. The need to save energy and reduce the energy demand of buildings is becoming a civic duty. Consequently, sacred buildings should also be adapted to the requirements of modern times. Due to the specific use of these facilities and their mostly large cubature, administrators rarely decide to take such measures. Examples of thermomodernization activities in church buildings can be invaluable as they are an example for administrators of other buildings of this type. The paper presents the following case study: A comprehensive thermal renovation of a church building in Rzerzęczyce.

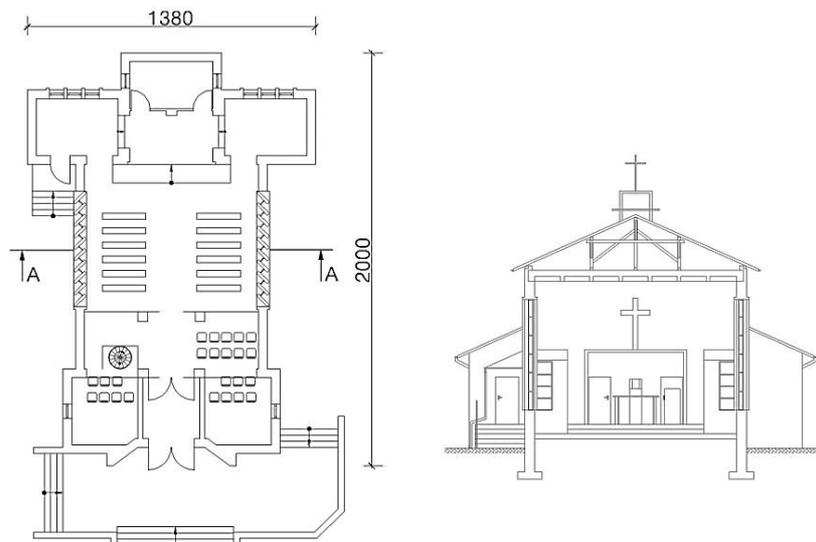
The church building is a one-story building without a basement. The usable area of the church is 158 m<sup>2</sup>. The rooms include the nave with the presbytery, sacristy, porch and choir. The floor plan of the church is in the shape of a cross (Fig. 1). The rectangular nave is covered with a gable roof. The height of the main nave is 6.4 m. The sacristy, chancel and porch are also rectangular-shaped, covered with gable roofs with the same slope as the roof over the main body. All the above-mentioned rooms are lower than the height of the nave of the church.

Fig. 1. Floor plan and vertical section A-A of the church in Rzerzęczyce

External walls of the nave and sacristy are made of slag blocks and bricks. The porch (added in 1992) is made of MAX ceramic blocks and perforated bricks. The internal walls are made of aerated concrete blocks. Above the building, there is a wooden roof truss, and the roof is covered with a trapezoidal galvanized sheet [1, 2].

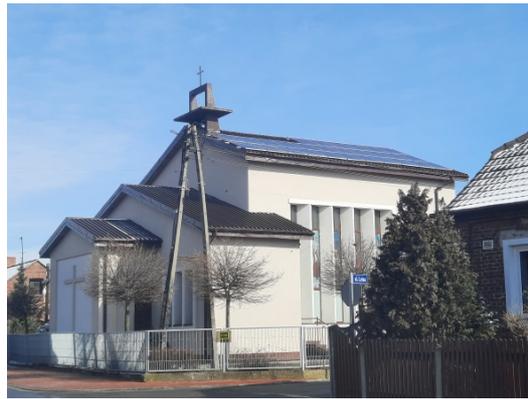
**Fig. 2.** A view of the church in Rzerzeczyce, photovoltaic panels can be seen on the southern roof slope

The church in Rzerzęczyce uses an air-to-water heat pump with a heating capacity of 26.01 kW and an electrical power consumption of 5.64 kW. The pump was located at the side wall of the building (Fig. 3). In addition, photovoltaic panels (Fig. 2) were installed on the entire southern slope of the roof, which powers the floor heating system and the electrical installation of the facility. The power of the photovoltaic installation on the church building is 7.28 kW. There are also pellet stoves in the boiler room, which can be used in the event of a particularly high load on the heating system. It should be noted that in the first year of use, during heating season 2020/2021, there was no need to start up these furnaces and despite the frosty weather, the power of the heat pump and photovoltaic panels was sufficient to heat the church. The church building in Rzerzęczyce is suitable for the use of underfloor heating, because the interior has a relatively low height and there is no problem with the presence of warm air masses being that much higher than the zone where people are [3].
